FOURTH FIVE-YEAR REVIEW REPORT OPERABLE UNITS 2 AND 4 SCHOFIELD BARRACKS HONOLULU COUNTY, HAWAII

AEDB-R Nos. SCHBR-19 and SCHBR-12

September 2017

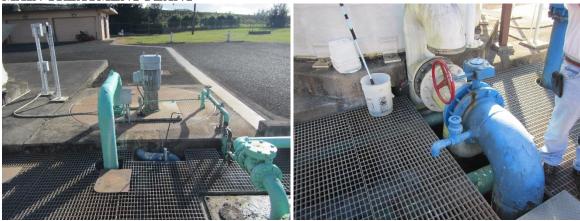
Figure C-1. Treatment plant piping.

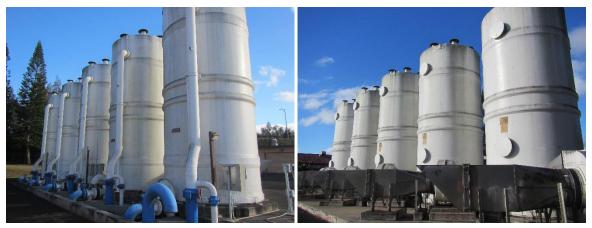
Figure C-4. Five air stripper towers, front and back.

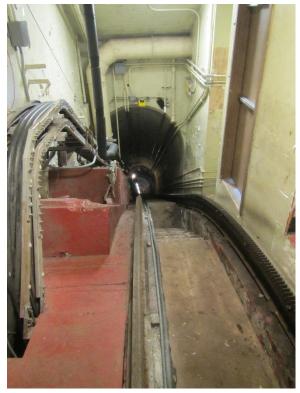
Figure C-5. Tunnel to the extraction pumps.

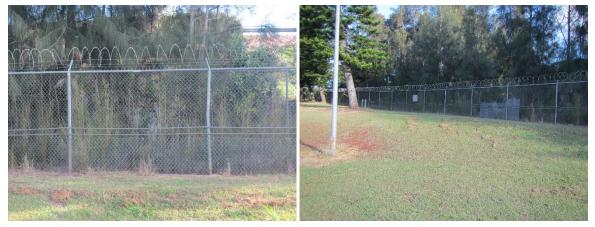
Figure C-6. Fencing.

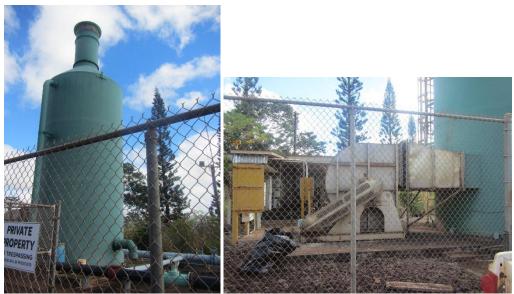
Figure C-8. Kunia air stripping tower and blower.

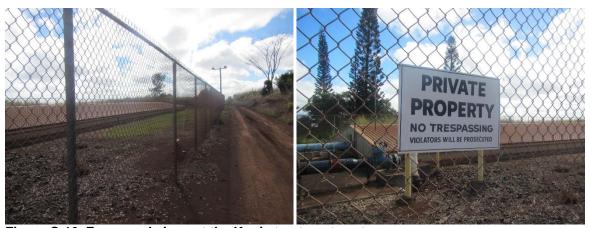
Figure C-10. Fence and signs at the Kunia treatment system.

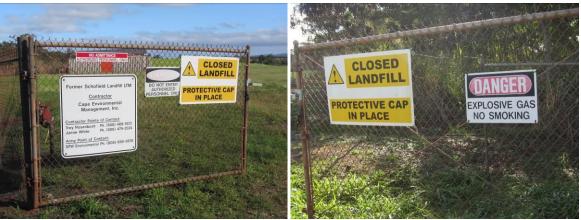
Figure D-1. Landfill entry gate and signs

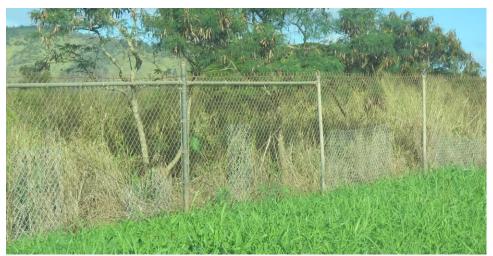
Figure D-2. Repairs along western fence

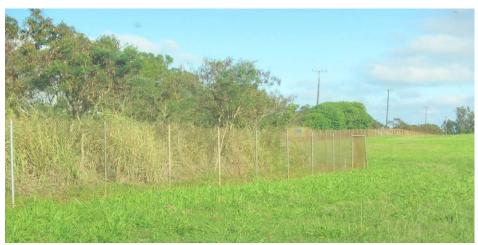
Figure D-3. Western fence

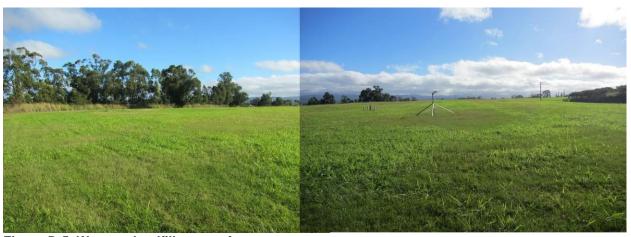
Figure D-5. Western landfill cap surface

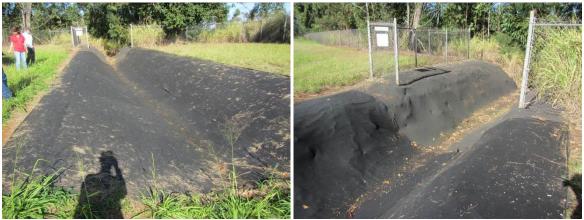
Figure D-7. Northwest drainage channel

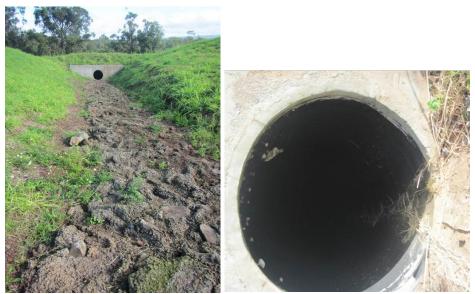
Figure D-8. Central drainage channel outlet

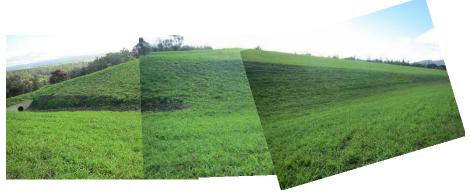
Figure D-9. Central drainage channel

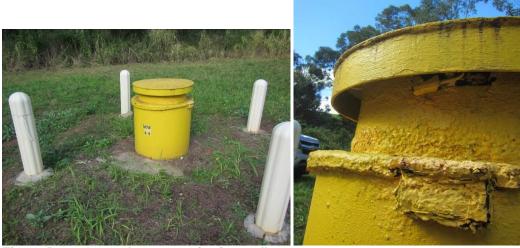
Figure D-11. Groundwater monitoring well
